**Reconnaissance-Level
Geologic Hazard Assessment Report**

Proposed Development
TNA Worldwide, LLC's Property
North of Sacchi Beach, Coos County, Oregon

June 24, 2024

Project No. 959-23014-01

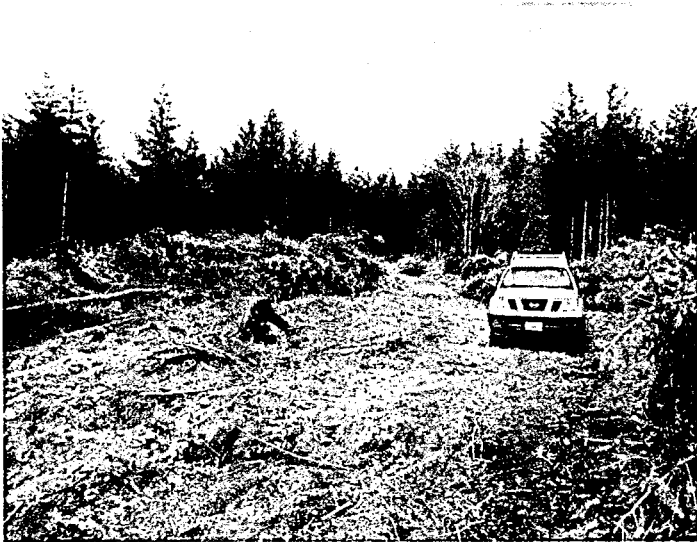
Looking north downslope of access road.

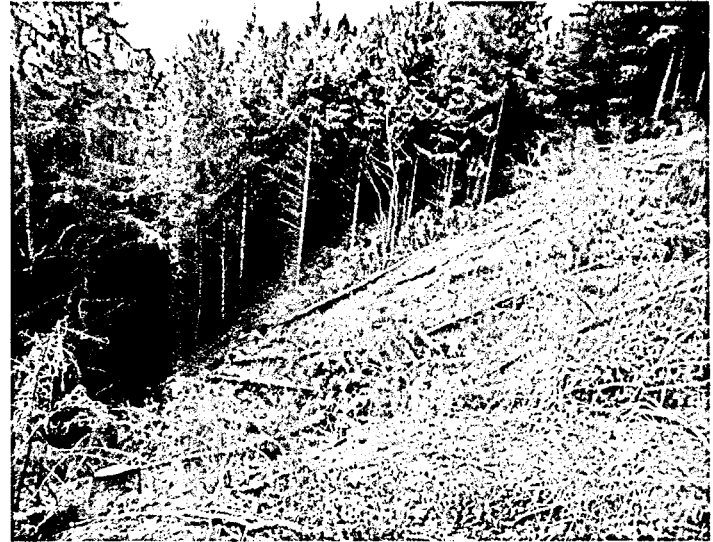
Looking north at top of slope at western extent of cleared proposed buildable area.

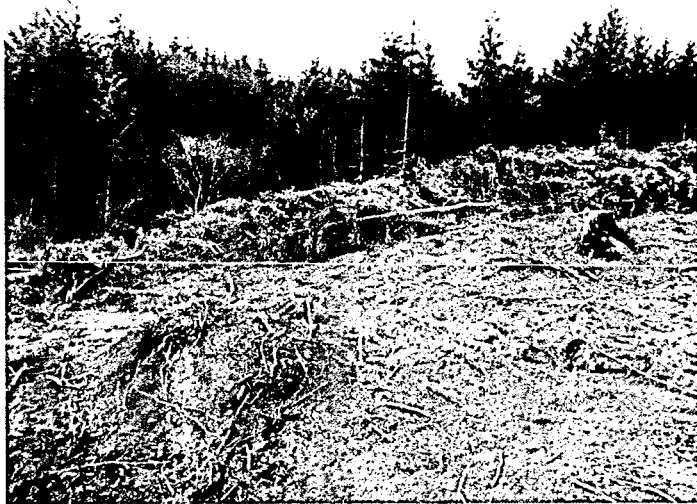
Looking northwest at northwest extent of cleared proposed buildable area.

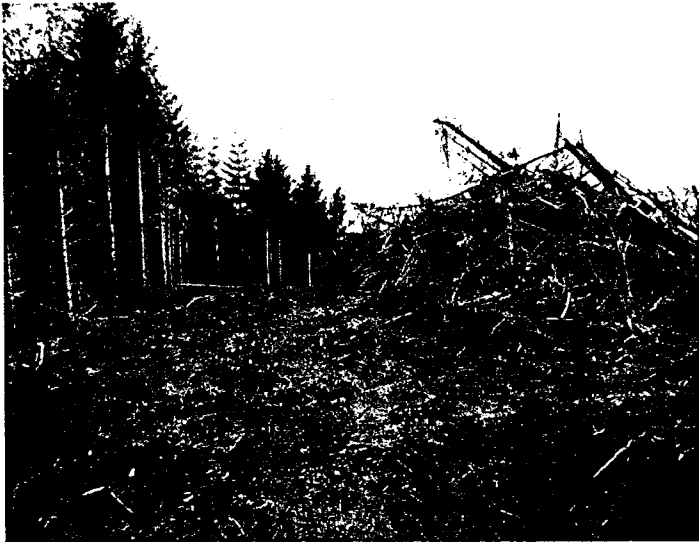
Looking south from eastern extent of cleared proposed buildable area.

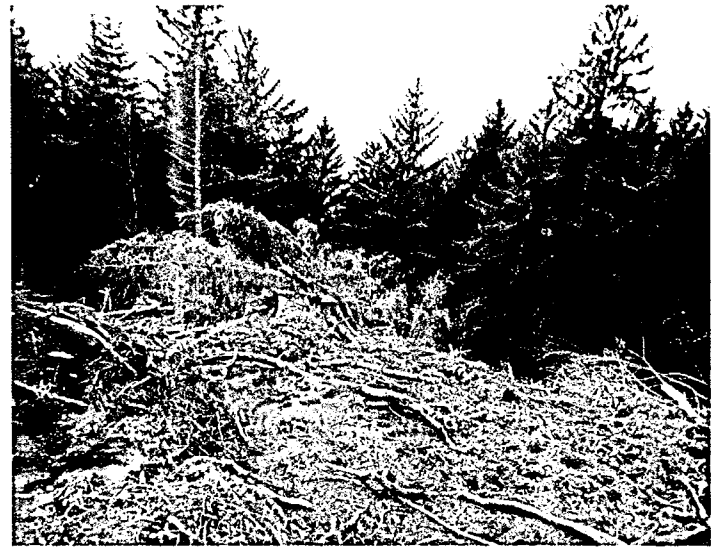
Look southwest at top of slope at southern extent of cleared proposed buildable area.

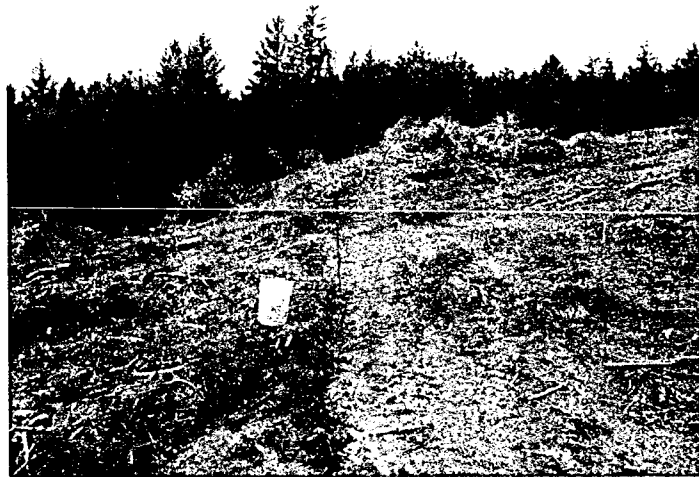
Hand auger boring 1 HB-1 located at center of western extent of cleared proposed buildable area.

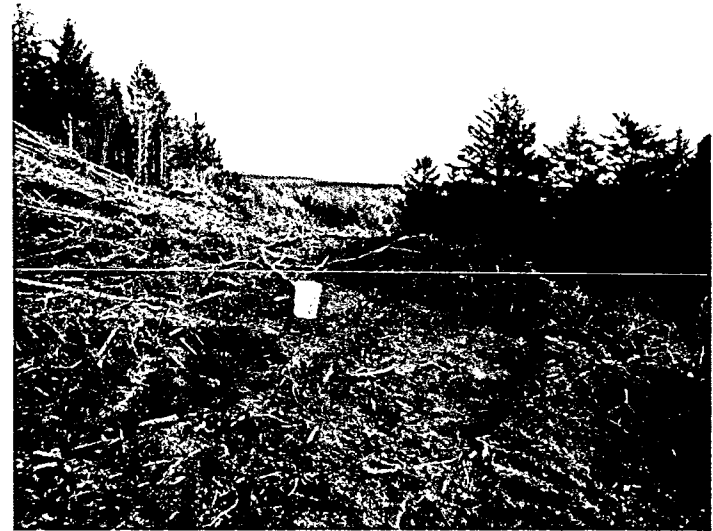
Hand auger boring 2 HB-2 located at southwestern extent of cleared proposed buildable area.

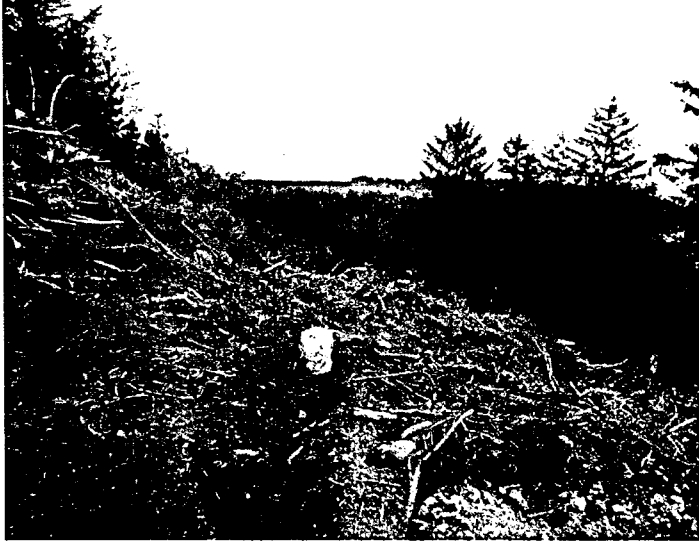
Hand auger boring 3 HB-3 located at southern extent of cleared proposed buildable area.

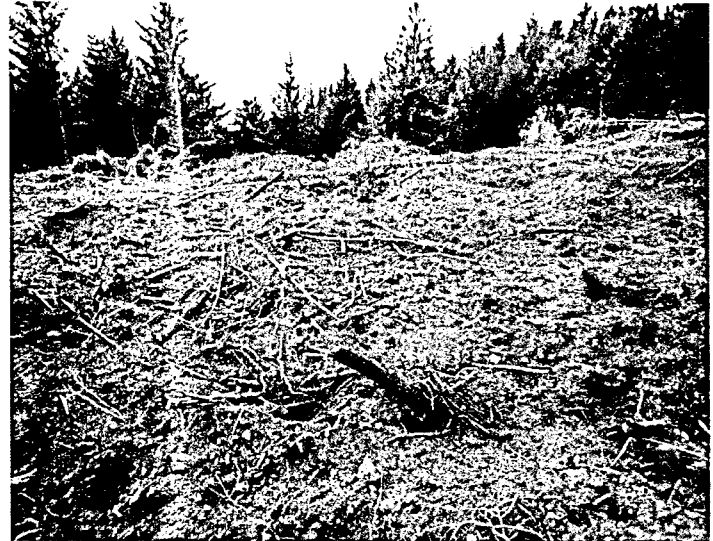
Looking northwest from center of property.

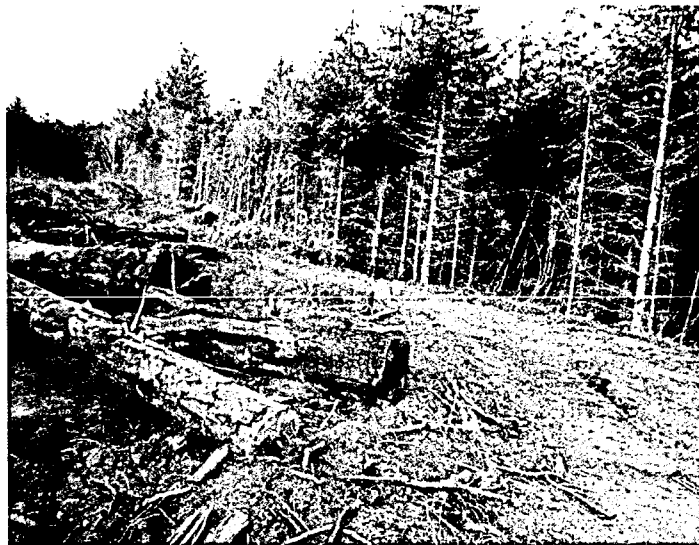
Hand auger boring 4 HB-4 located at center of eastern extent of cleared proposed buildable area.

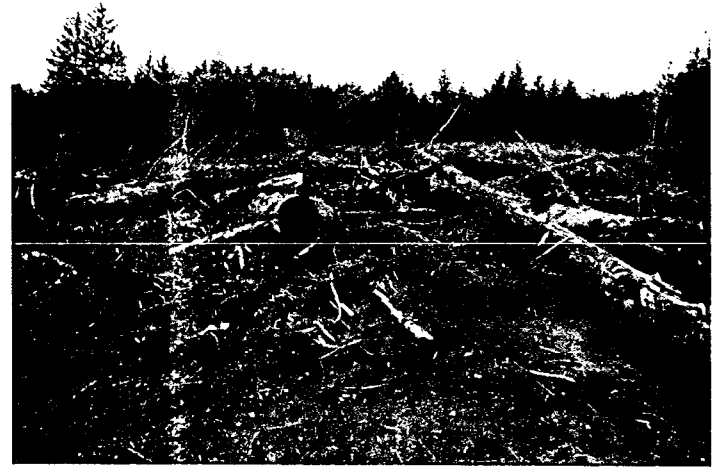
Looking north from center of property.
